T-55 Engine Compressor Stator Vane Investigation

ARL-TR-2123

November 1999

Weapons and Materials Research Directorate, ARL

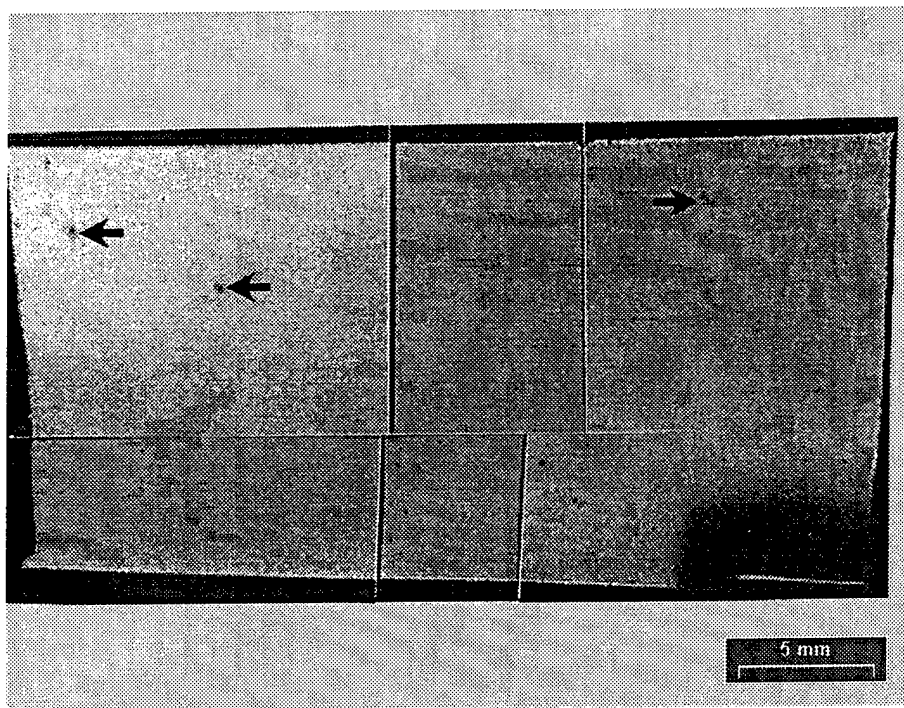
The previous findings obviously constituted failure of the visual requirements stipulated by AMS 2400 Rev. S [2]. The corrosion observed on the as-received components was indicative of a coating system that was not capable of providing protection under normal environmental conditions. It was readily apparent that this coating system would not be adequate to pass the engine corrosion test requirement, an environment much more severe than our standard atmosphere.

Figure 3. Concave Side of a Single Vane Showing Corrosion Pits.

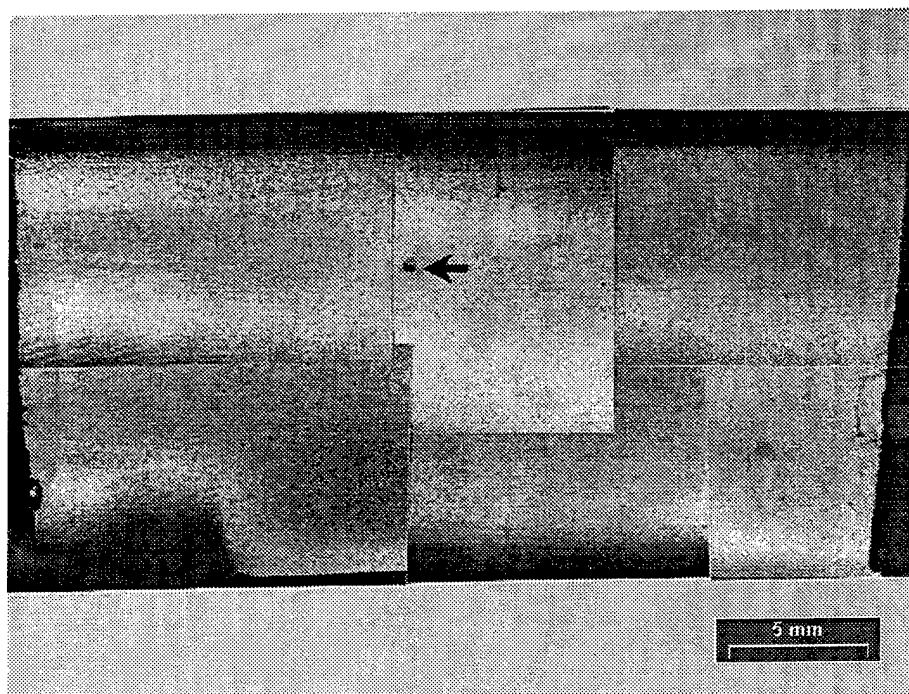
Figure 4. Convex Side of a Single Vane Showing Corrosion Pits.

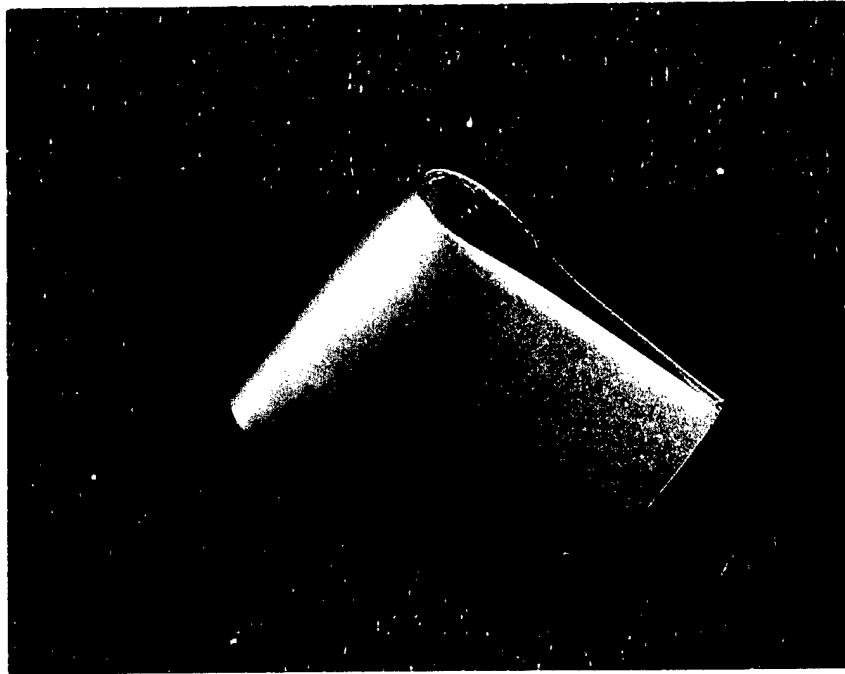
specimens shall not show separation of the plating from the basis metal, when examined at 4× magnification, after being bent rapidly, in accordance with ASTM-E-290, through an angle of 180° around a mandrel with a diameter equal to the thickness of the specimen [2, 3]. A single vane was carefully sectioned from the interior and exterior shroud of the assembly. The sectioned vane was then bent around a mandrel with a diameter approximately equal to the thickness of the vane. The bent vane can be observed in Figure 7. No evidence of failure was noted.

Figure 7. ARL Vane Bend Test Specimen (Magnified Approximately 3×).

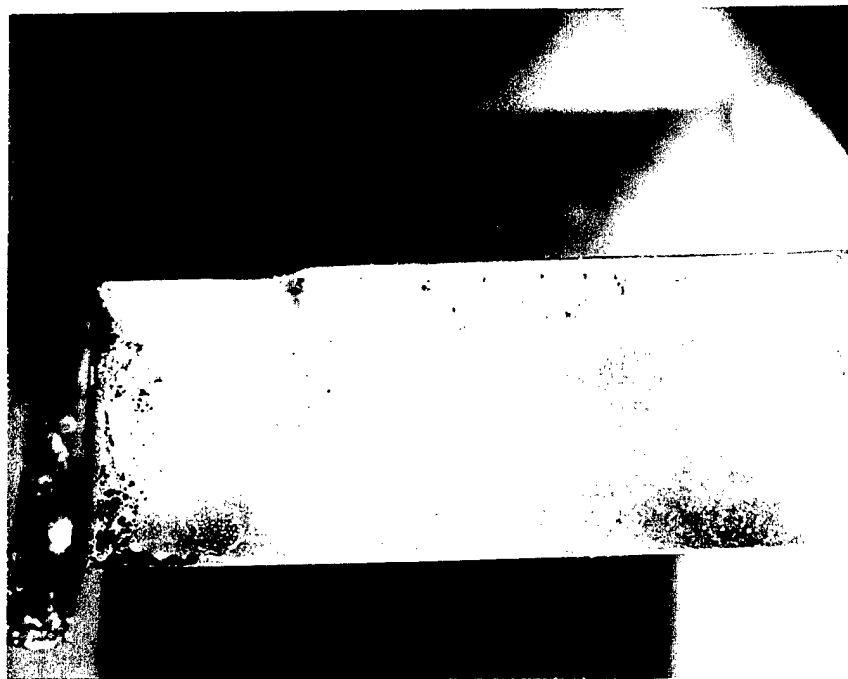
3.4 Corrosion Testing. According to AMS 2400 Rev. S, ferrous metal parts shall show no visual evidence of corrosion of the basis metal after being subjected to a 200-hr continuous salt fog exposure conducted in accordance with ASTM-B-117 [2, 4]. The assembly in the as-received condition would have failed the corrosion resistance test criteria based upon the visual examination, due to the presence of the dark corrosion pits. However, the test was conducted to alleviate doubt. Figures 8, 9, and 10 show the vanes after 24, 125, and 200 hr of exposure, respectively. The dark corrosion spots increased in magnitude, and corrosion of the base metal occurred, constituting failure. Figure 10 is a color depiction to more clearly

Figure 8. Typical Vane Corrosion After 24 hr Salt Fog Exposure (Magnified Approximately 3 \times).

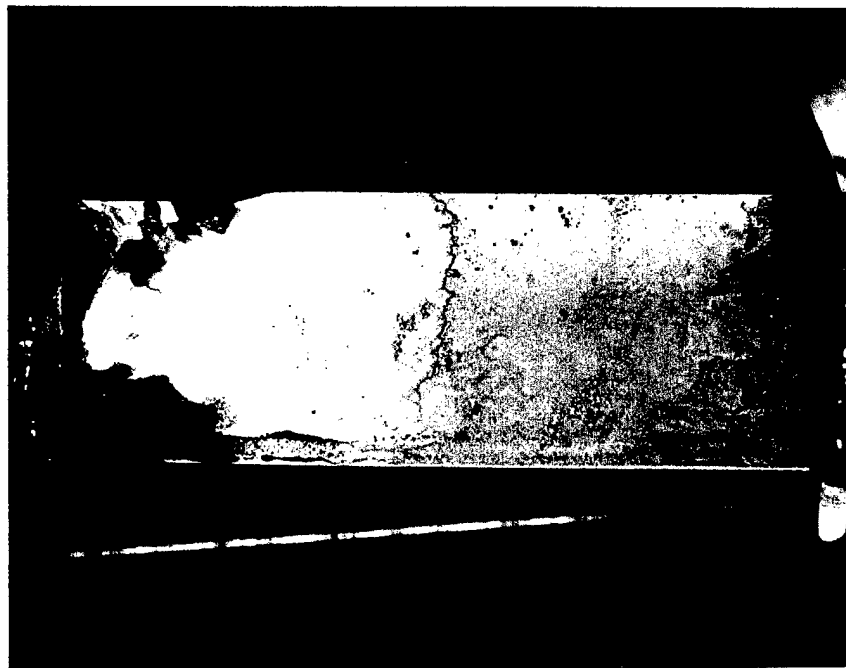
Figure 10. Typical Vane Corrosion After 200 hr Salt Fog Exposure (Magnified Approximately 3 \times).

demonstrate the magnitude of the corrosion. The stator section obviously failed the corrosion resistance requirement.

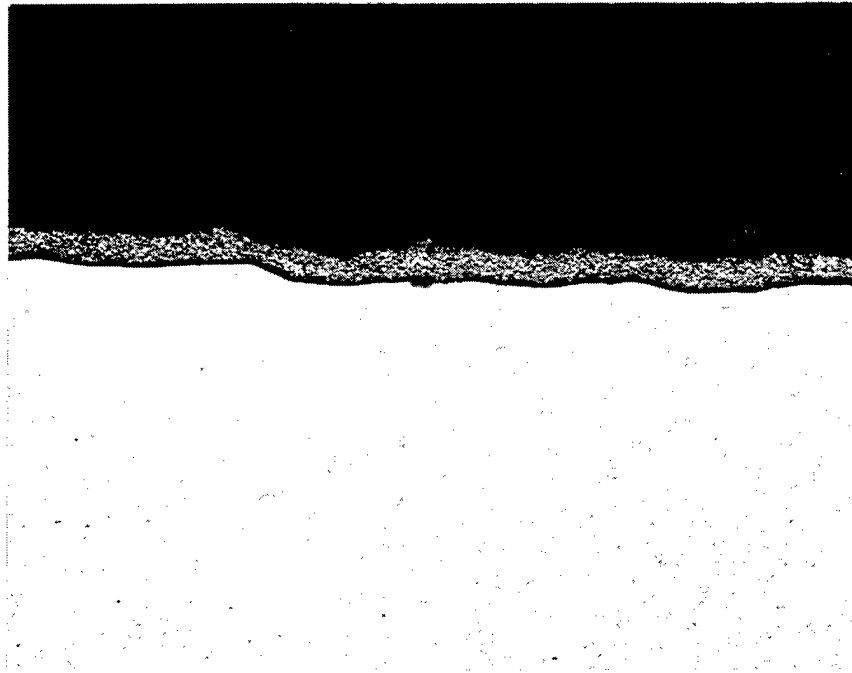
3.5 Coating Thickness. These components were designated to have a 2400-3 coating system, according to AMS 2400 Rev. S [2]. Table 1 of AMS 2400 Rev. S lists the thickness requirement for designation 2400-3 as 0.0003–0.0005 in, with the only exception being that this only applies to areas that can be touched by a 0.75-in-diameter sphere, as established in section 3.4.1.4 [2]. Cross-sections of several vanes were prepared metallographically and examined per ASTM-B-487 [5]. Figure 11 shows a representative area along the convex side of a vane near the inner shroud where the cadmium plating was approximately 0.0003 in thick. In contrast, Figure 12 is indicative of the nonuniform cadmium plating observed on much of the concave side of a vane near the inner shroud. In this area there is only a hint of plating evident, which would account for the poor corrosion resistance.

Figure 11. Cadmium Plating Thickness on the Convex Side of the Vane (Magnified 500 \times).

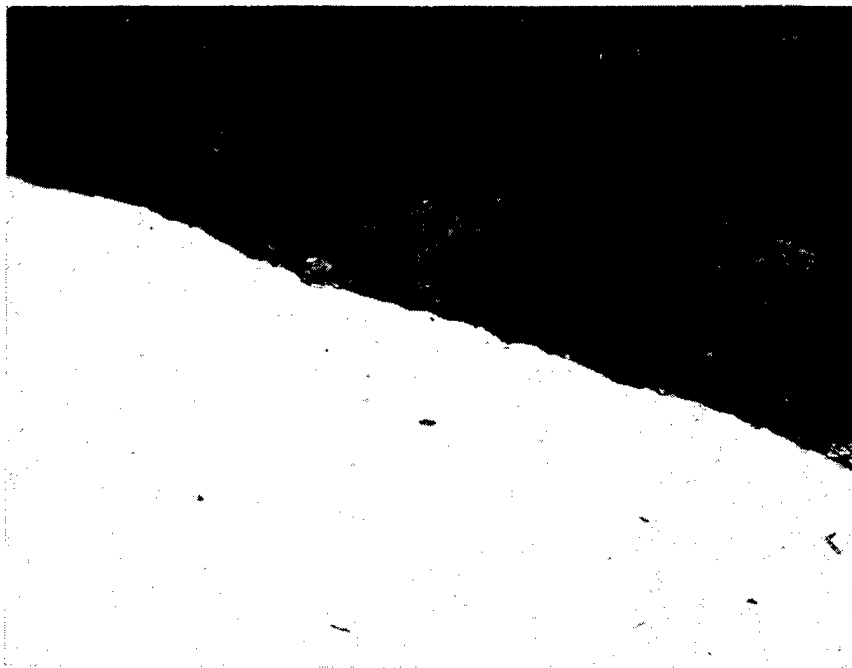
Figure 12. Cadmium Plating Thickness on the Concave Side of the Vane (Magnified 500 \times).

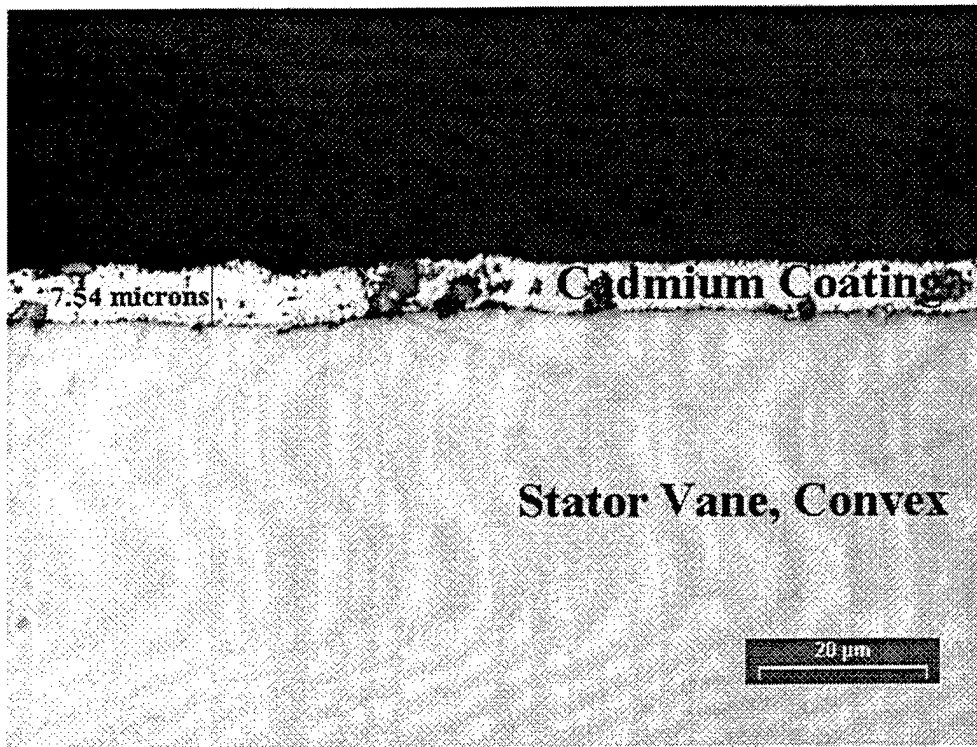
Figure 13. Typical Plating Thickness on the Convex Side of the Vane.

Measurements were taken in several locations along the components. The results show that the coating was thin in most locations but especially near the inner shroud where corrosion was abundant after the 200-hr salt fog test. Table 1 presents the cadmium thickness measurements, including the locations, taken on the part.

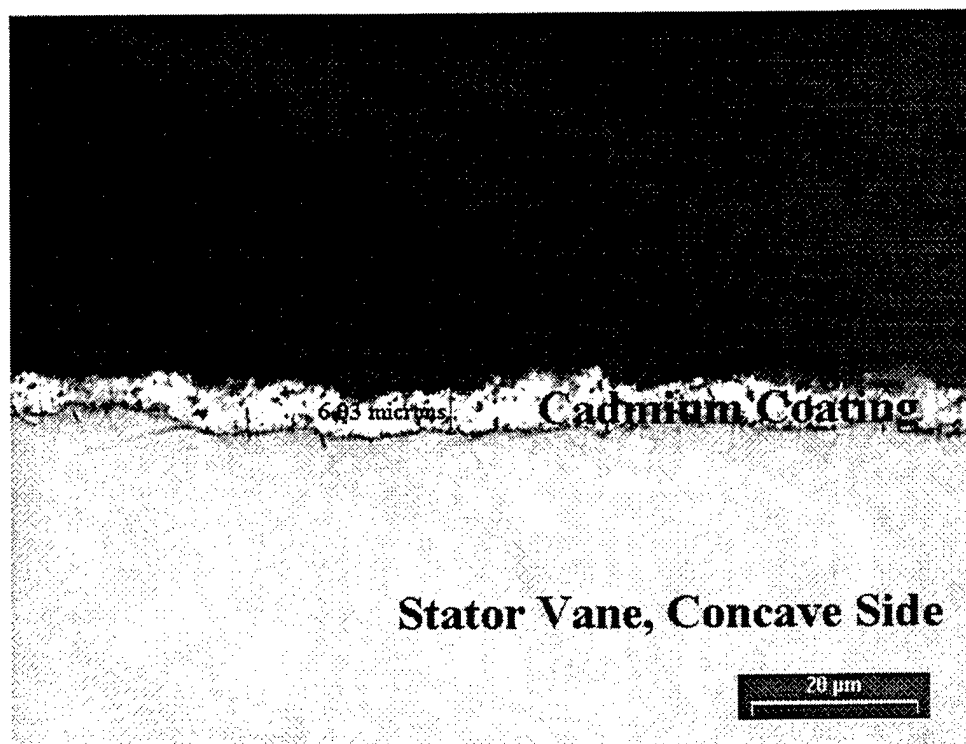
Figure 14. Typical Plating Thickness on the Concave Side of the Vane.

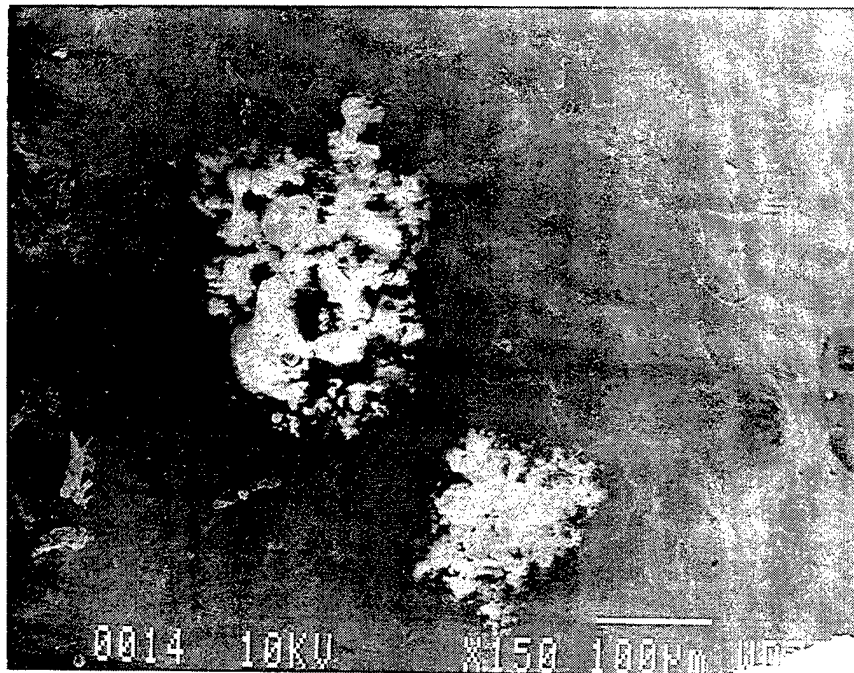
dark areas of corrosion were verified to be pits containing a significant amount of corrosion product. A cadmium plating was detectable on all surfaces; however, in some instances, base metal elements were also detectable, indicating a thin or discontinuous coating. Figures 15 and 16 show the corrosion product within the pits in both secondary and backscatter electron imaging, respectively.

Figure 15. Secondary Electron Image of Corrosion Product Within a Pit (Magnified 150×).

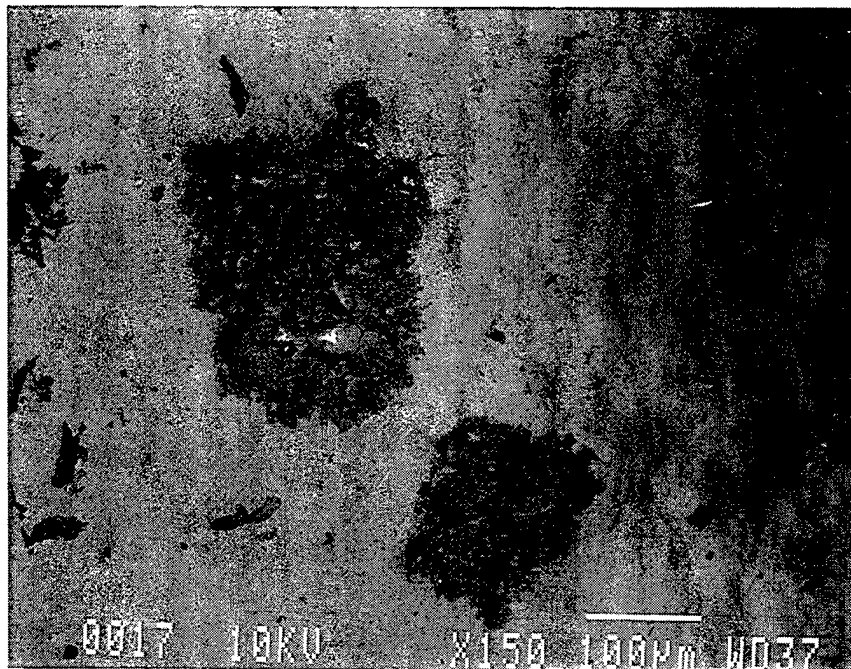
Figure 16. Backscatter Electron Image of the Product Within a Pit (Magnified 150×).

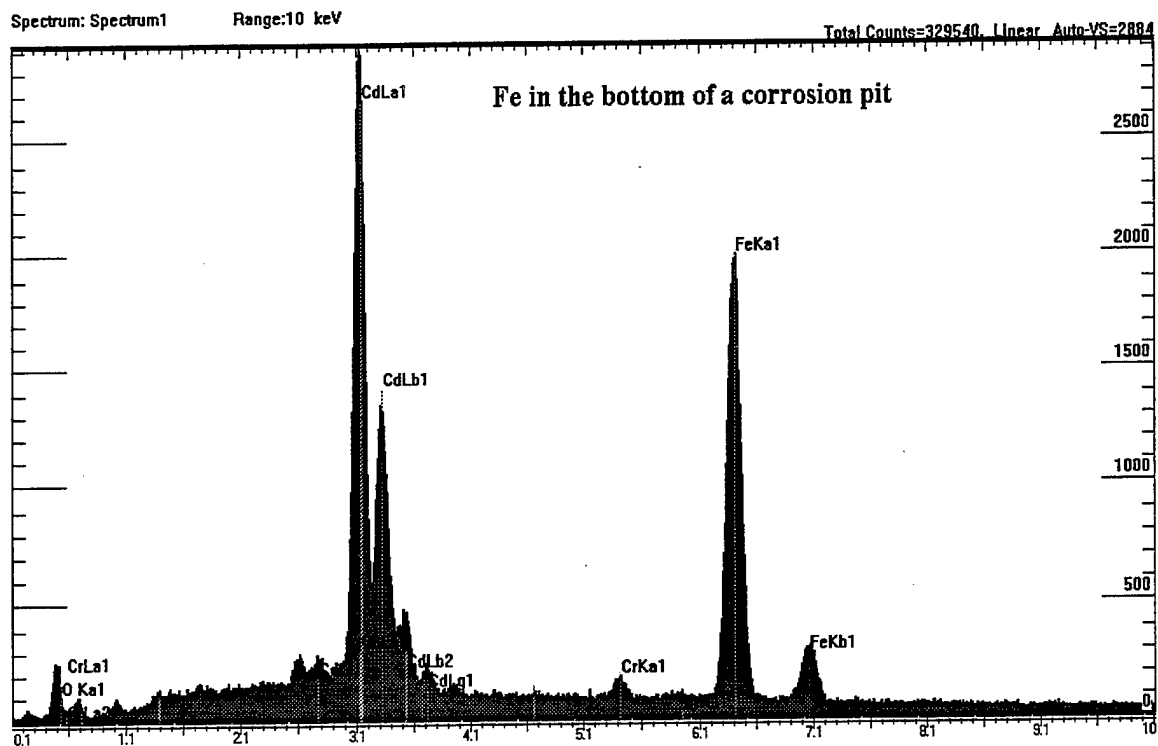
These corrosion pits were found to extend to the base metal as evidenced by the Fe peak in the EDS spectrum. This is depicted in Figure 17.

Figure 17. EDS Spectrum Showing Iron Within the Corrosion Pit.

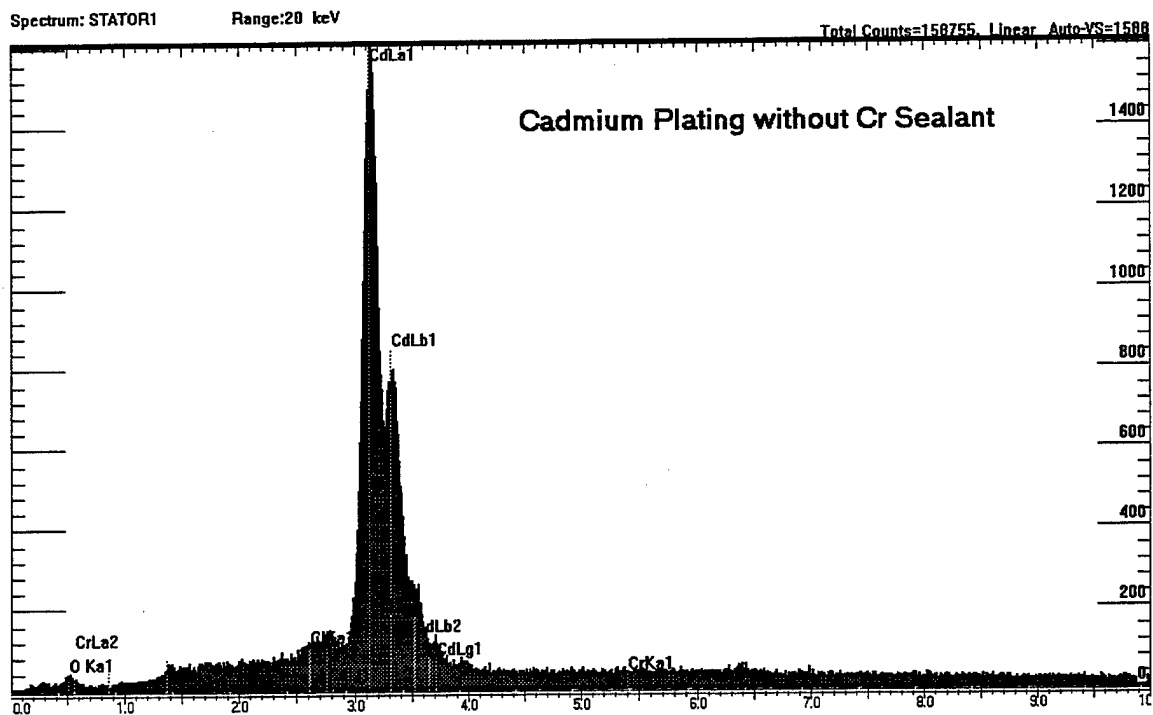
Specification AMS 2400 Rev. S stipulates that the cadmium must be sealed with a chromic acid sealant or with a chromate or phosphate treatment when specifically approved [2]. An attempt was made to verify the existence of a chromium or phosphorus sealer over the cadmium coating. These sealers would be evidenced by the presence of the elements Cr or P, respectively, within the EDS spectrum. Neither element was observed above the scatter within the EDS spectrum. Figure 18 presents the EDS spectrum from a representative stator vane. The only elements observable in Figure 18 are oxygen (O) and cadmium (Cd). To further investigate, a cadmium-plated nut known to have a chromate sealer was analyzed and indeed was found to contain a significant amount of the element Cr within, or on top of, the cadmium coating. Figure 19 presents the EDS spectrum showing the Cr peak. These findings suggest that either the sealer was absent or below detectable limits. In either case, the corrosion protection afforded would be minimized.

Figure 18. EDS Spectrum Displaying the Absence of Cr on the Stator Vane.

the EDS spectrum, as previously discussed. The element was not observed above the background of the EDS spectrum. Figure 18 depicts a similar EDS spectrum showing the absence of chromium over cadmium plating. Typically, chromated and chromic-acid-treated components do contain measurable amounts of Cr. These findings show either the sealer was absent or below detectable limits. In either case, the corrosion protection afforded would be minimized. This minimal protection was demonstrated under salt fog exposure. The old section with 2.33% chromic acid treatment nearly outperformed the recoated section that had almost twice the cadmium coating thickness and no detectable chromate or chromic acid treatment.

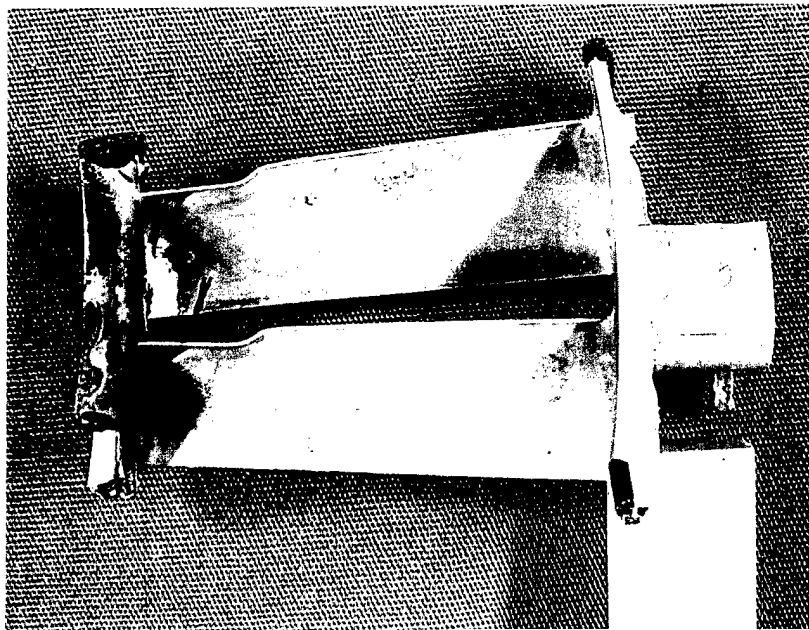
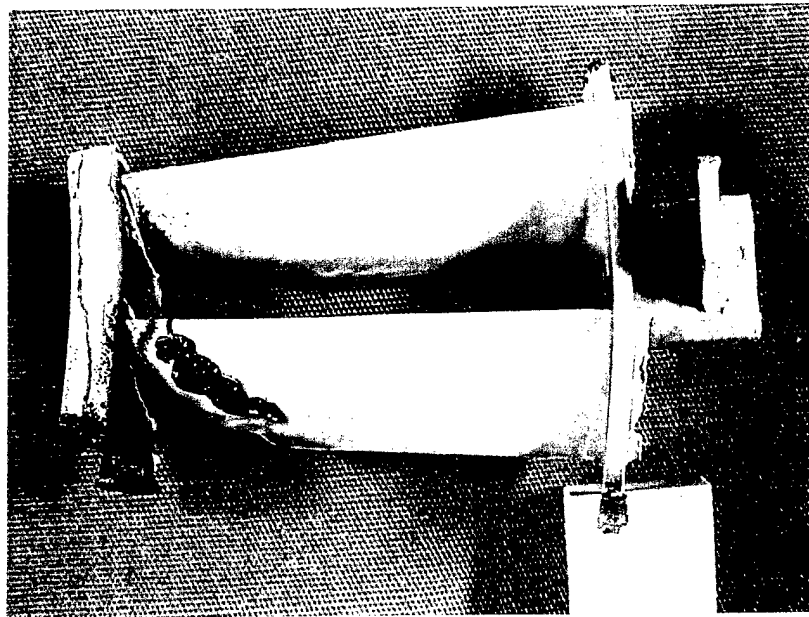
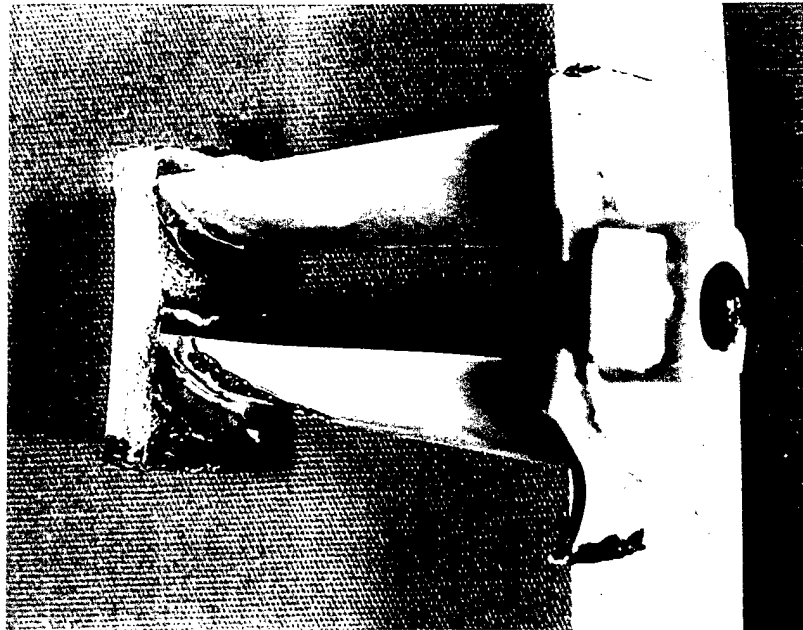
Figures 42–44 depict the 2.33% dipped old stator after 200 hr of salt fog exposure per ASTM-B-117. Some slight corrosion was evident along the braze and inner shroud. However, this section appeared to completely inhibit the white cadmium oxide product from forming and looked the best in comparison to the other sections.

Figure 42. 2.33% Dipped Stator After 200 hr Salt Fog Exposure, Concave Side (Magnified 1.5 \times).

Figure 43. 2.33% Dipped Stator After 200 hr Salt Fog Exposure, Convex Side (Magnified 1.5 \times).

Figure 44. 2.33% Dipped Stator After 200 hr Salt Fog Exposure, Braze Area (Magnified 1.5 \times).

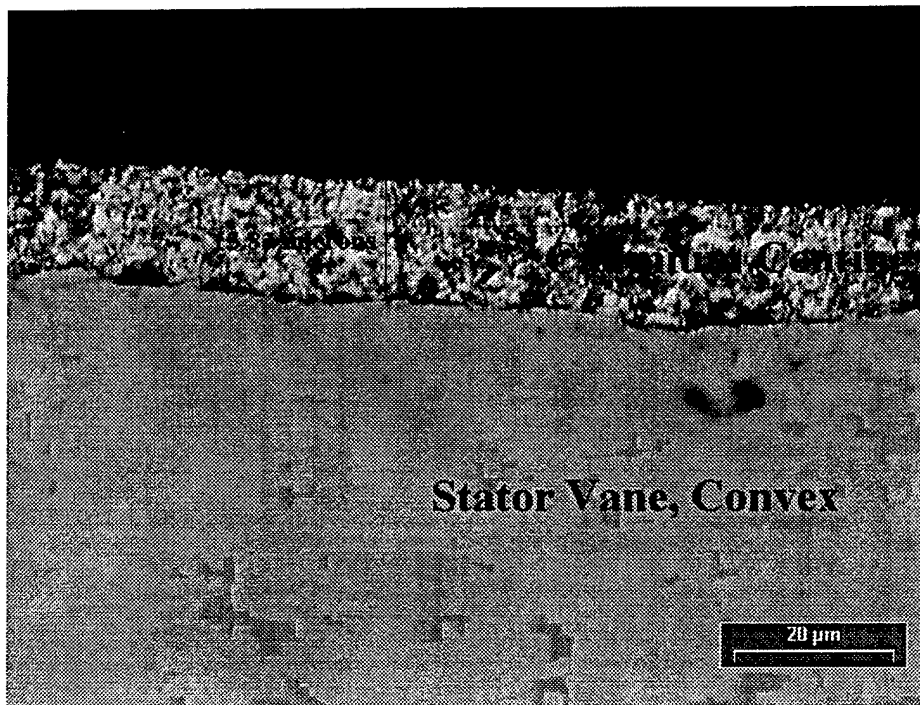
4.2 Coating Thickness. Similar cross sections of several vanes were prepared metallographically and examined per ASTM-B-487, as previously discussed [5]. Figure 48 shows a representative area along the convex side of a vane near the inner shroud where the cadmium plating was approximately 0.00065 in thick. In contrast, Figure 49 is indicative of the

Figure 48. Cadmium Plating Thickness of New Stator Near Inner Shroud, Convex Side.

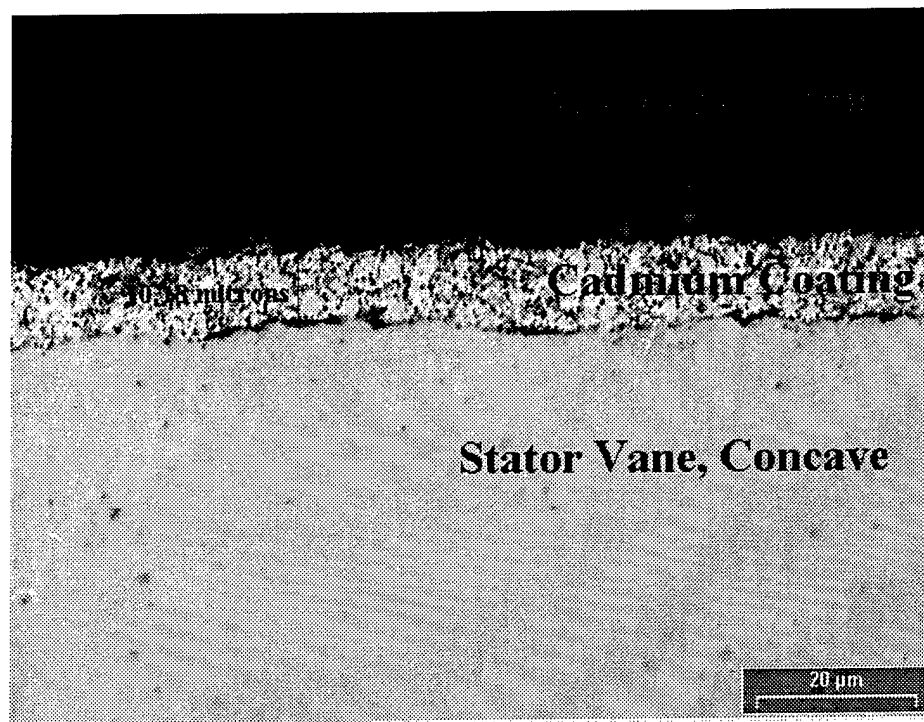
Figure 49. Cadmium Plating Thickness of New Stator Near Inner Shroud, Concave Side.

cadmium plating observed on much of the concave side of a vane near the inner shroud where the thickness was approximately 0.00043 in.

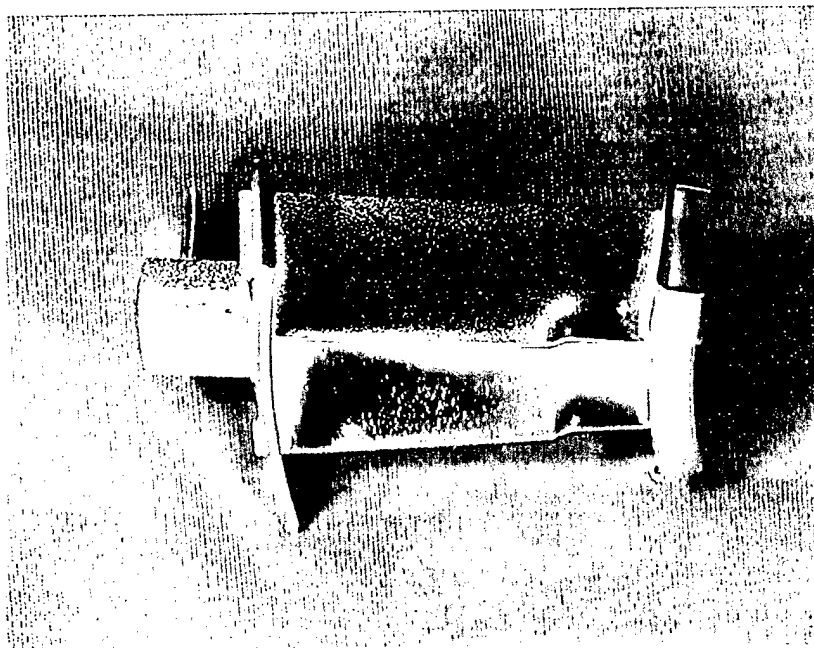
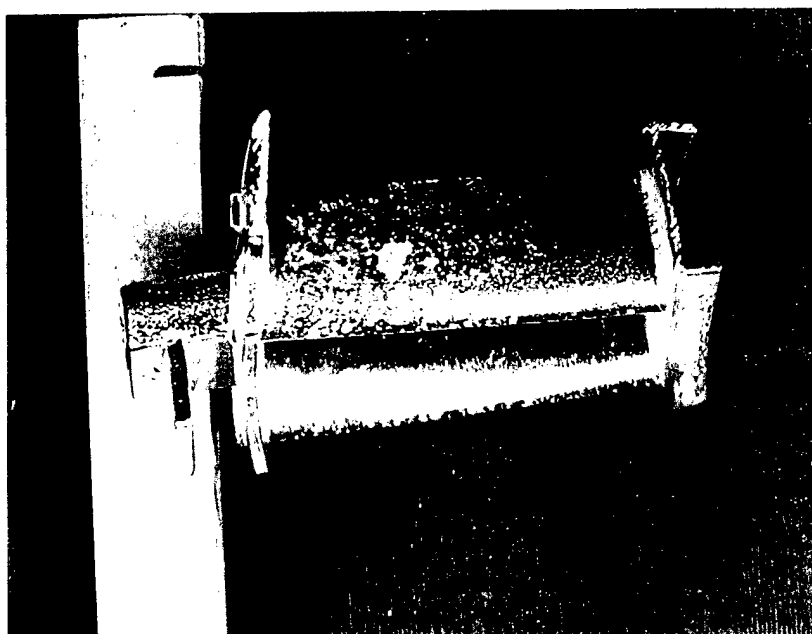
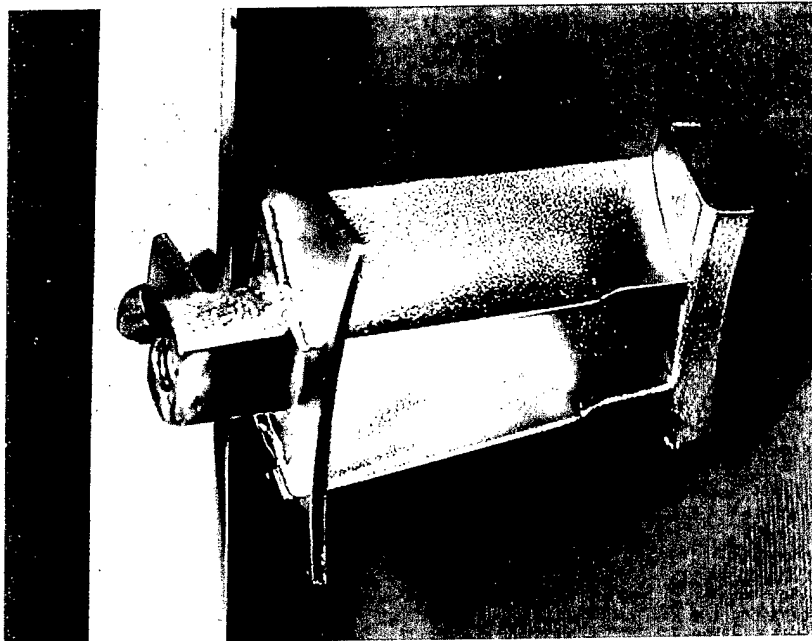
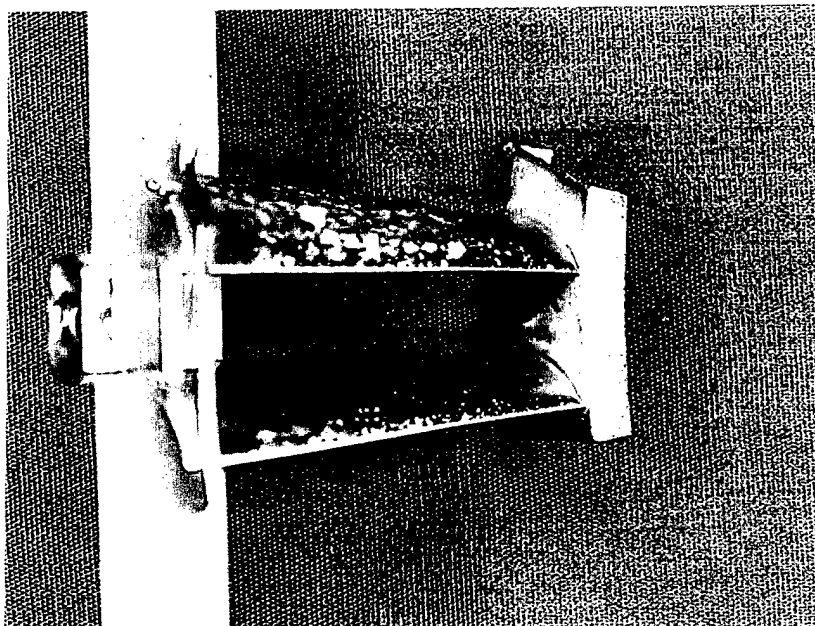
After 200 hr exposure, the new stator barely exhibited any significant white product along the vane and no pitting within the braze area, as shown in Figures 58–61. Only some small water spots on the convex side of the vane were evident.

Figure 58. 200 hr Salt Fog Exposure of the Stator, Concave Side (Magnified 1.5x).

Figure 59. 200 hr Salt Fog Exposure of the Stator, Convex Side (Magnified 1.5x).

Figure 60. 200 hr Salt Fog Exposure, Braze Area, Concave Side (Magnified 1.5×).

Figure 61. 200 hr Salt Fog Exposure, Braze Area, Convex Side (Magnified 1.5×).

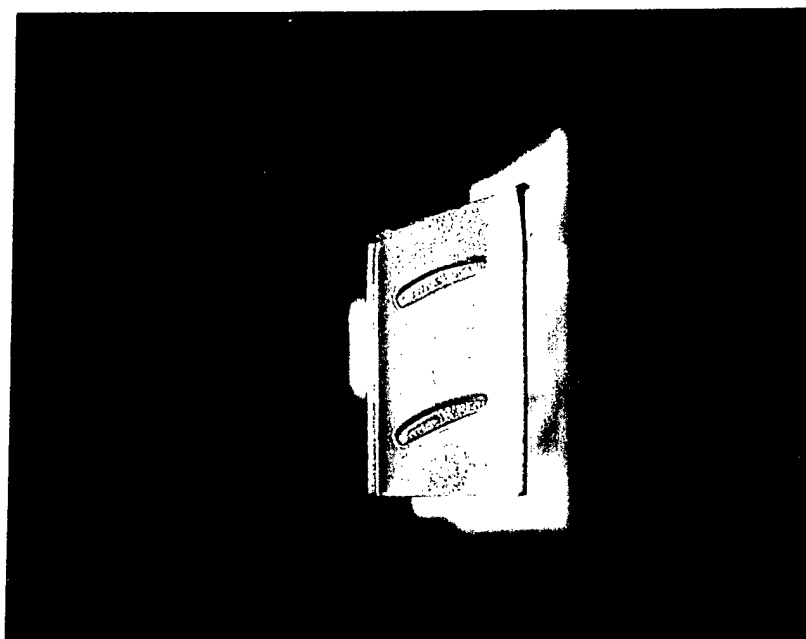
Figure 62 shows the inside edge of the inner shroud where significant corrosion had occurred on previous samples. No corrosion was visible on this stator section. After the 200-hr exposure period, the yellow hue had started to fade but was still evident. The chromic acid treatment appeared to have greatly increased the performance of the components under salt fog exposure testing, as expected. This stator section's corrosion resistance satisfied the requirements of the governing specification.

Figure 62. Inside Edge of Inner Shroud Showing Brazed Vanes (Magnified 1.5×).
